PHASE IV REPORT

VOLUME II

RESULTS AND INTERPRETATION OF CHEMICAL GROUTING TEST PROGRAM

EXISTING LOCKS AND DAM NO. 26
MISSISSIPPI RIVER, ALTON, ILLINOIS

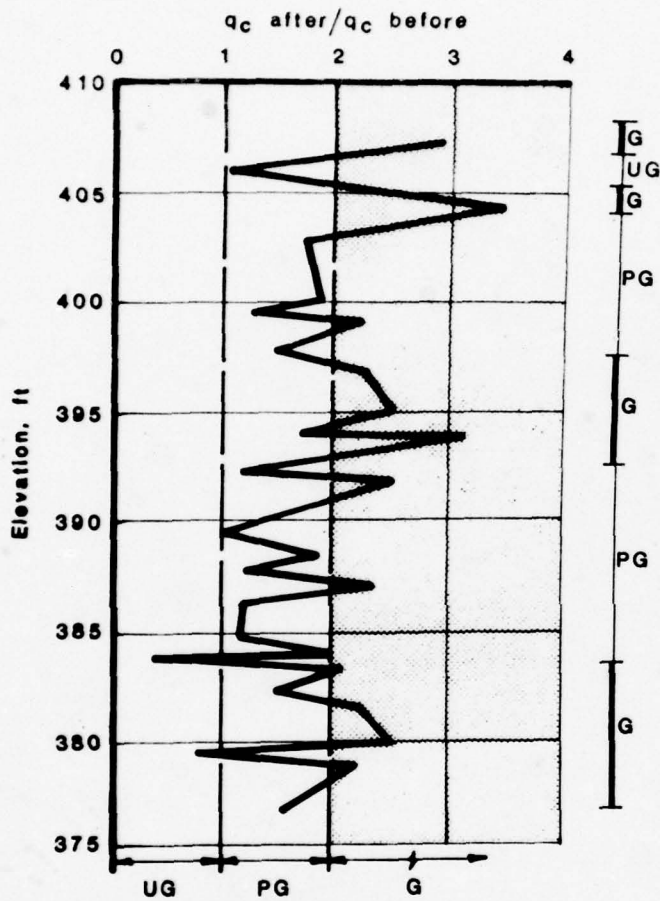
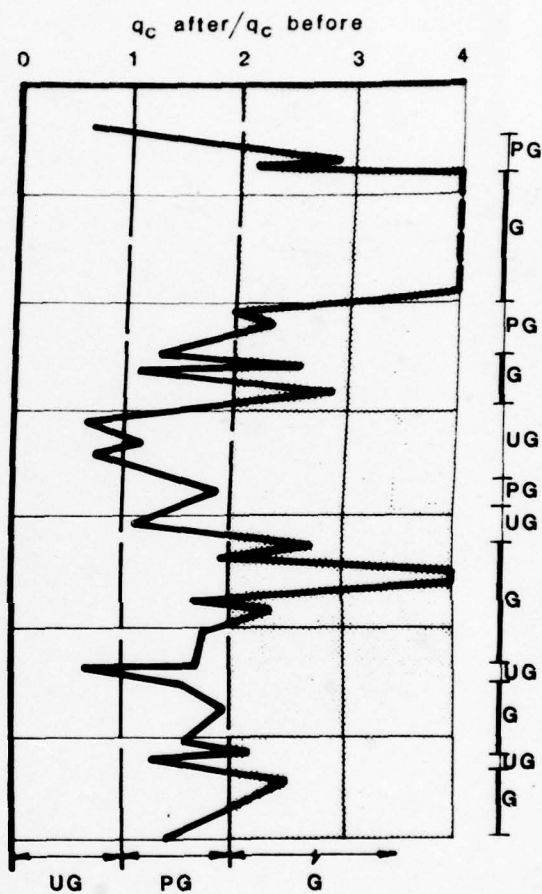
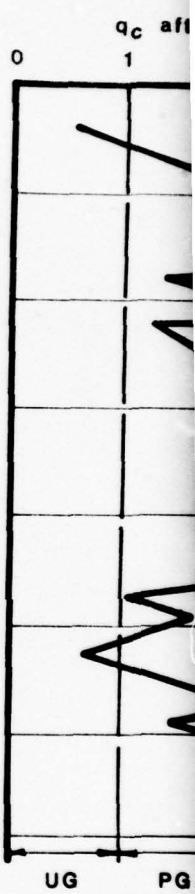
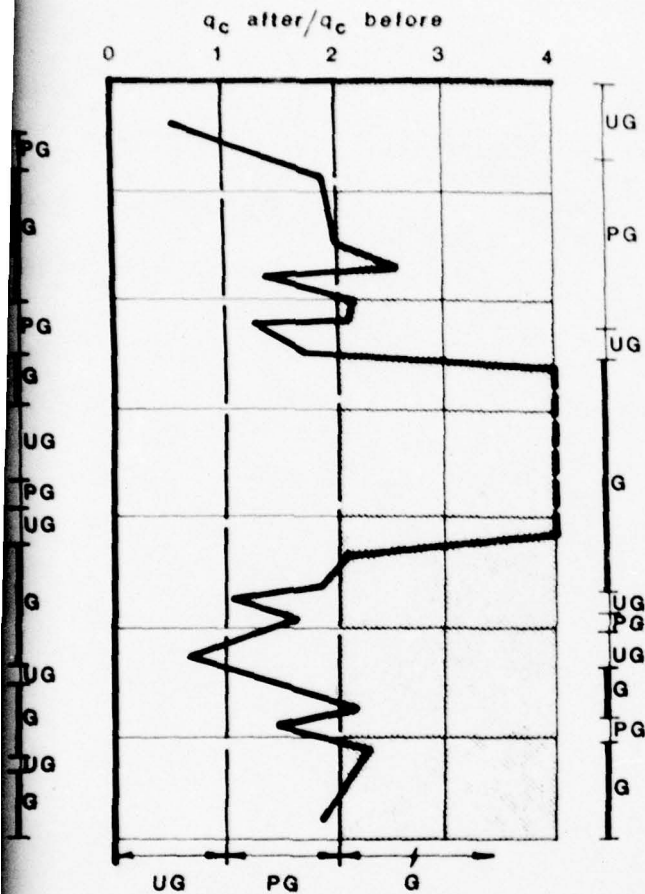
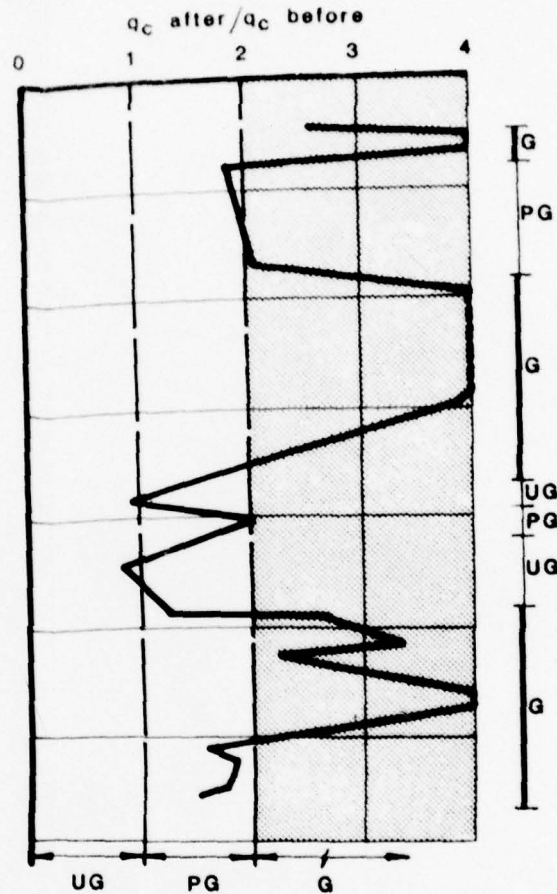
Fig. 9.28

Boring AG-A8-3
Subarea 8
25% Silicate/Aluminate
Grouting method S₃
4-ft spacing

Boring AG-A3-2
Subarea 3
28% Silicate/R600
Grouting method S₂
6-ft spacing

Boring AG-A3-2
Subarea 3
45% Silicate/R600
Grouting method S₂
6-ft spacing

Boring AG-A5-21
Subarea 5
45% Siroc 132
Grouting method S₂
6-ft spacing

Boring AG-A9-2
Subarea 9
55% Siroc 132/142
Grouting method O₁
4-ft spacing

CHEMICAL GROUTING TEST PROGRAM
COMPARISON BETWEEN
STATIC CONE PENETRATION
RESISTANCE BEFORE AND
AFTER GROUTING

Examples of actual grout pumping pressure vs time are shown in Fig. 9.28. The interpretation of each of these records was confirmed by the results of the excavation mapping. These examples illustrate how grouting records can be interpreted to follow progress and assess efficiency of the grouting process.

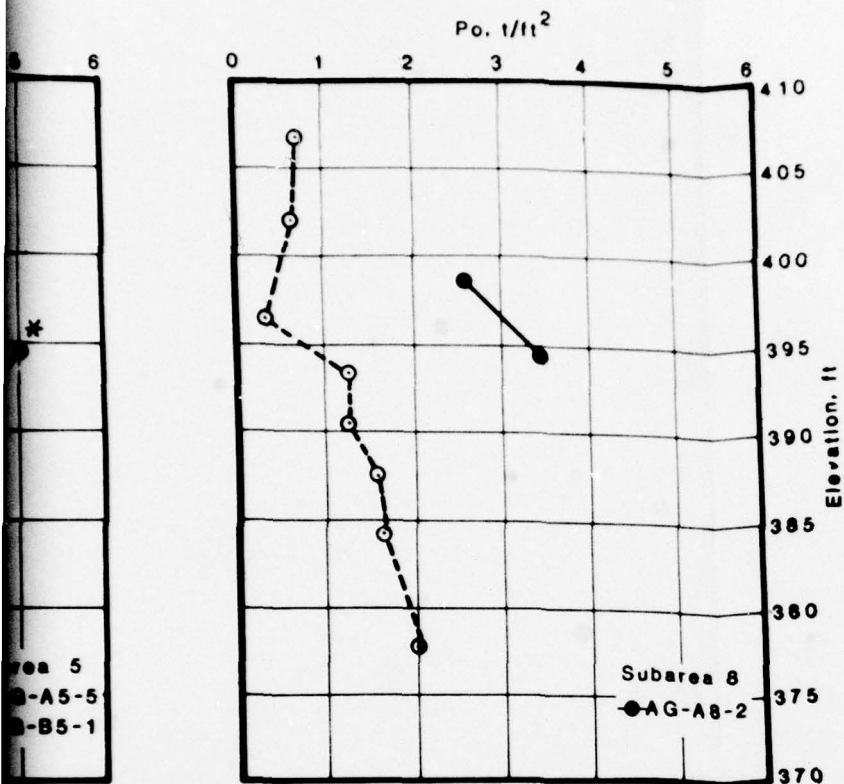
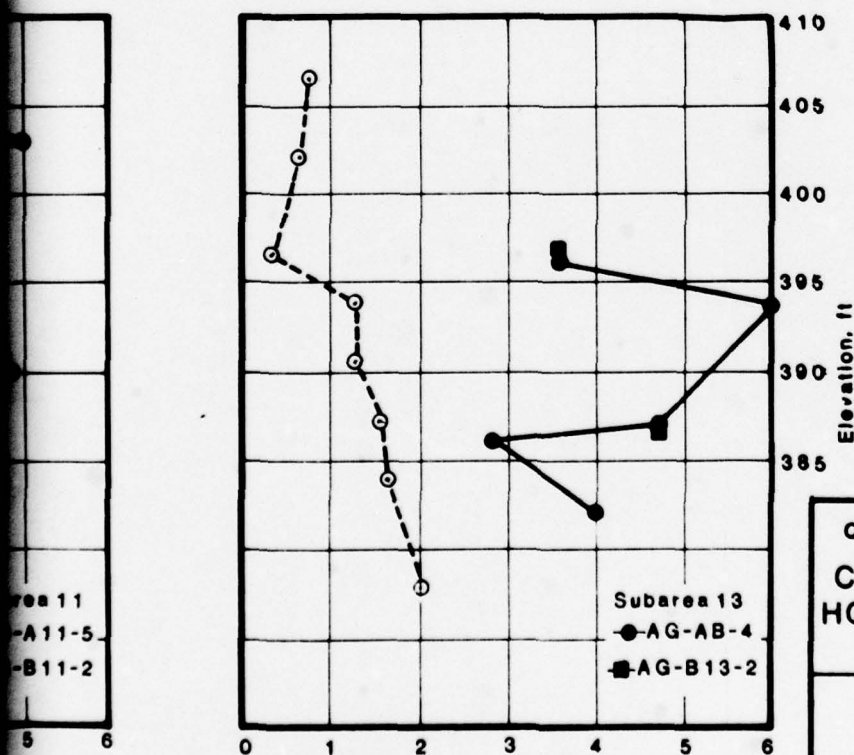
CHEMICAL GROUTING TEST PROGRAM COMPARISON BETWEEN IN SITU HORIZONTAL STRESS P_0 BEFORE AND AFTER GROUTING

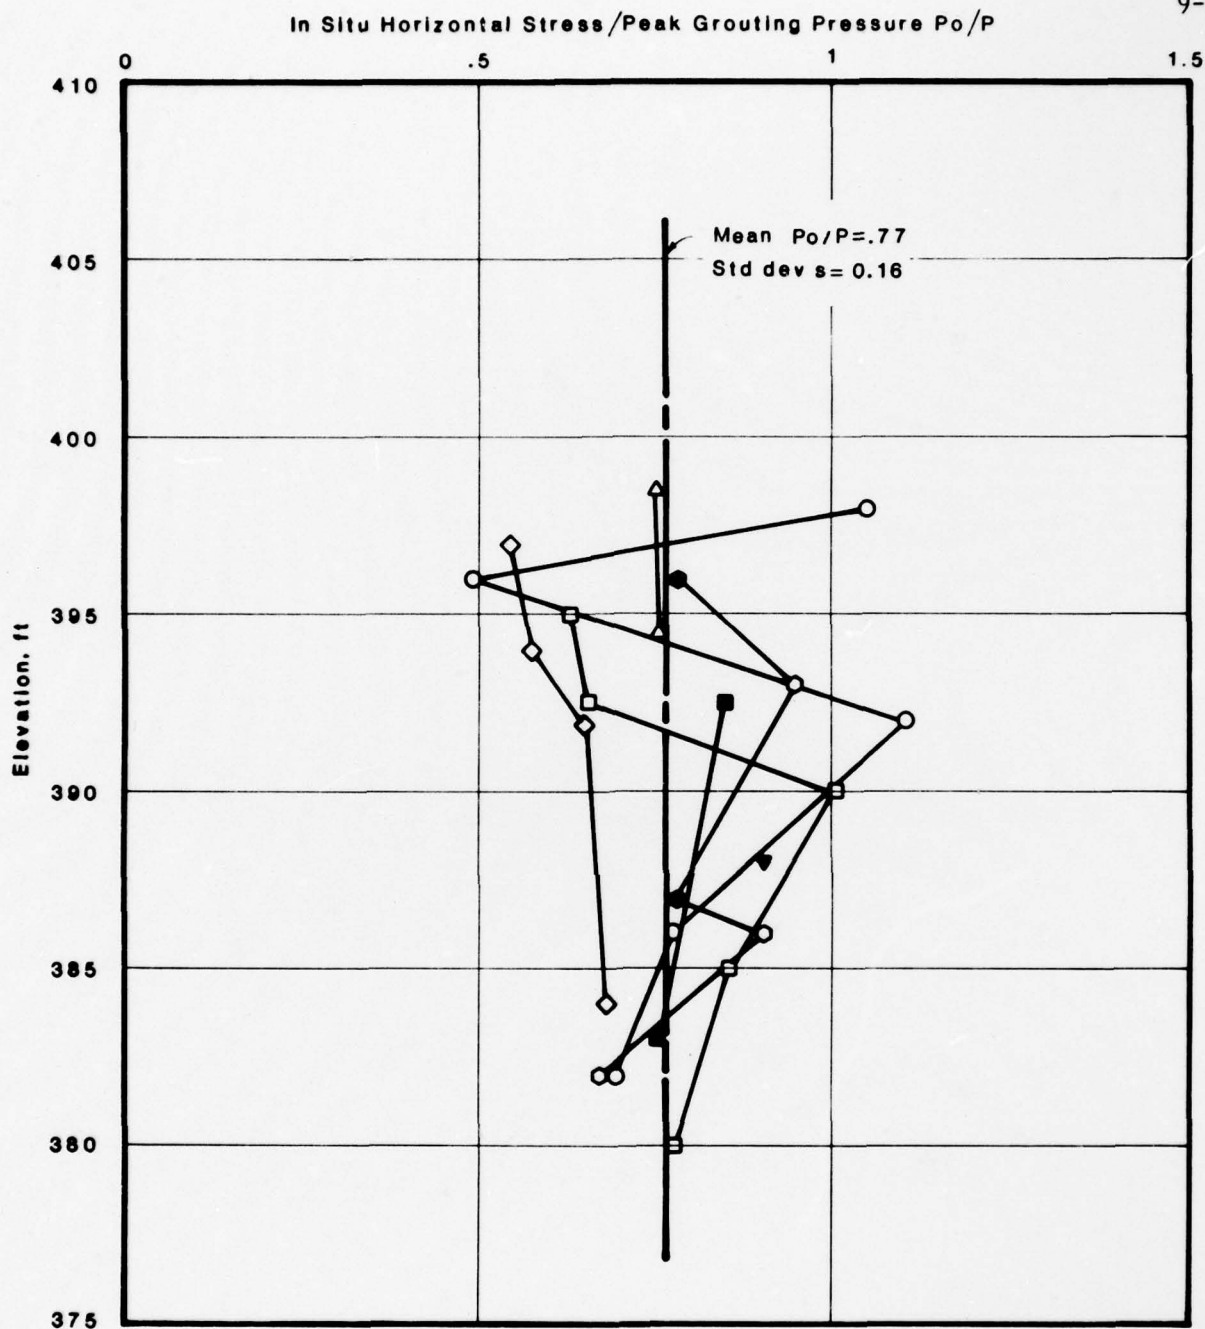
Fig. 9.35

CHEMICAL GROUTING TEST PROGRAM
COMPARISON OF GROUTING
PRESSURE AND
AFTER-GROUTING
IN SITU HORIZONTAL STRESS

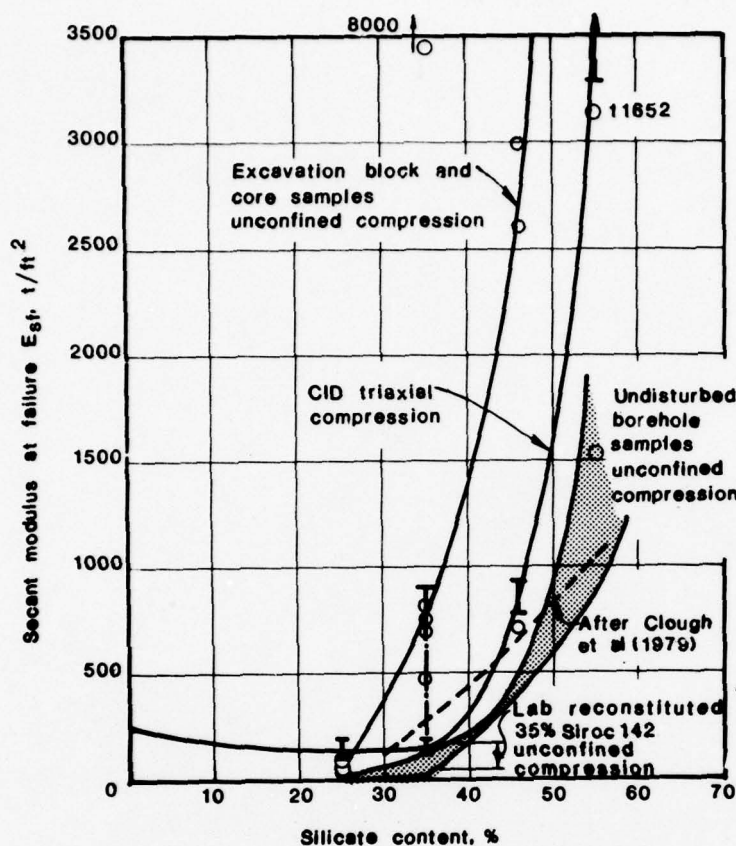
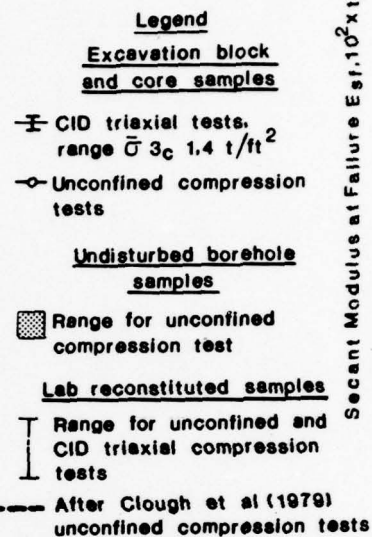
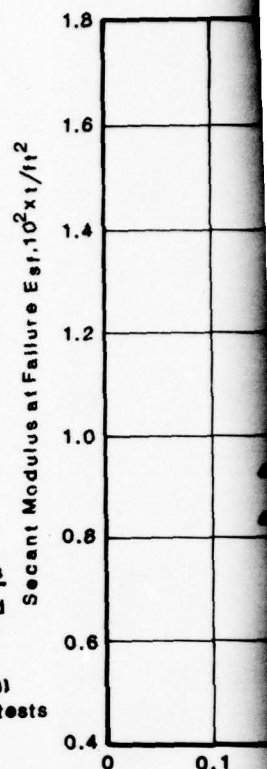
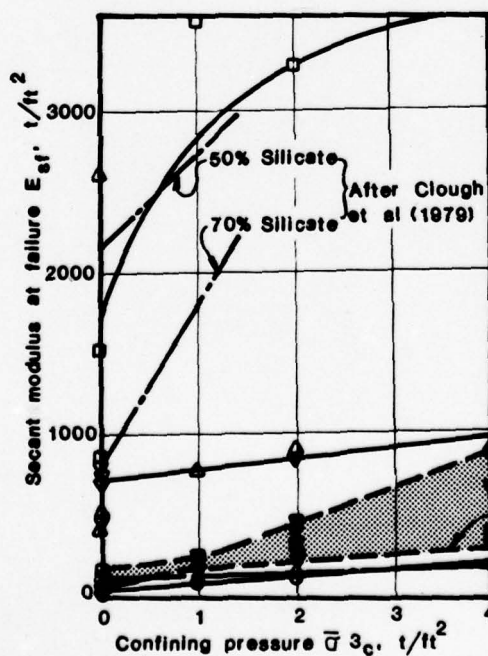
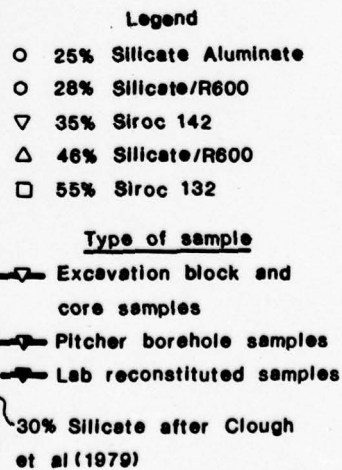
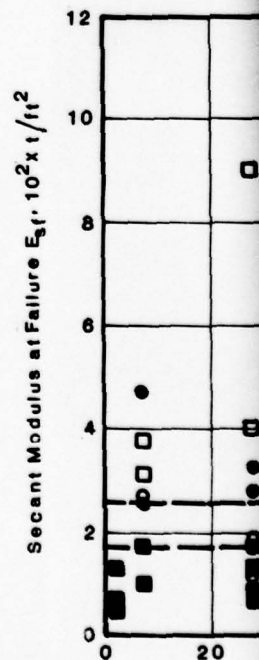
Fig. 9.40

INFLUENCE OF VARIOUS FACTORS ON LABORATORY ELASTIC DEFORMATION MODULUS

The influence of strain rate on modulus is illustrated in Fig. 9.41b. From the limited range of strain rates studies, it appears that modulus values increased with faster strain rates, although considerable scatter was found at strain rate of 0.5 percent per minute. This is consistent with the trend observed by Clough et al (1979). Koenzen (1978) showed that the effect of strain rate on modulus diminishes with decreasing percentage of silicate.

The influence of confining pressure on modulus is illustrated in Fig. 9.41c. Modulus values increased with confining pressure. Clough et al (1979) showed similar trends, with the rate of increase of modulus with confining pressure being greater for higher silicate content. The influence of curing time on modulus is illustrated in Fig. 9.41d. Modulus values did not appear to increase with curing time, contrary to the findings of Clough et al (1979).

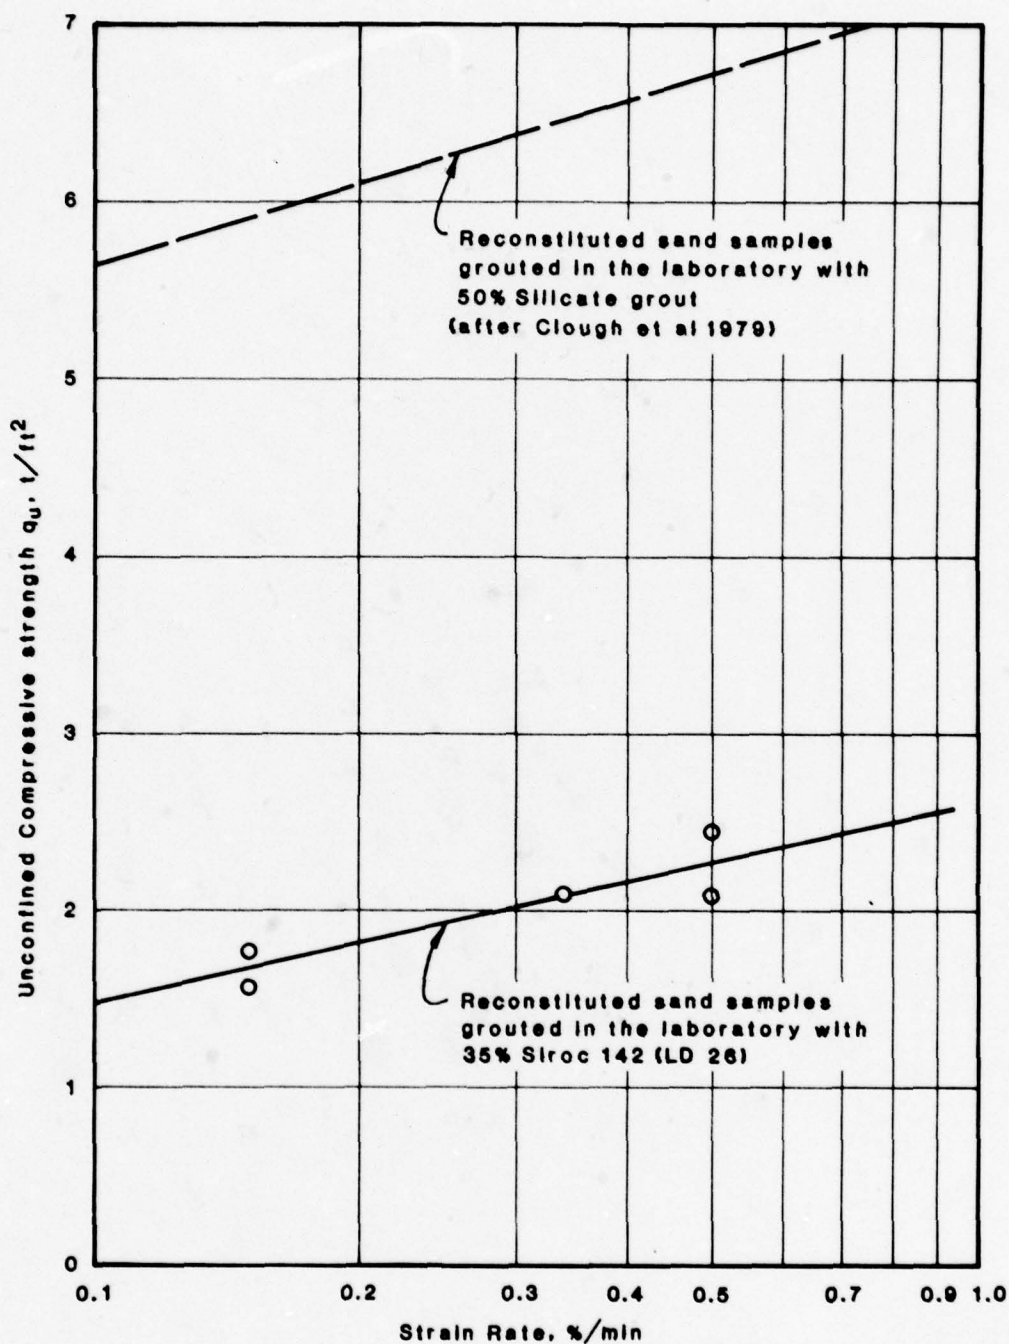
Fig. 9.44

CHEMICAL GROUTING TEST PROGRAM
INFLUENCE OF STRAIN RATE
ON UNCONFINED COMPRESSIVE
STRENGTH OF GROUTED SAND

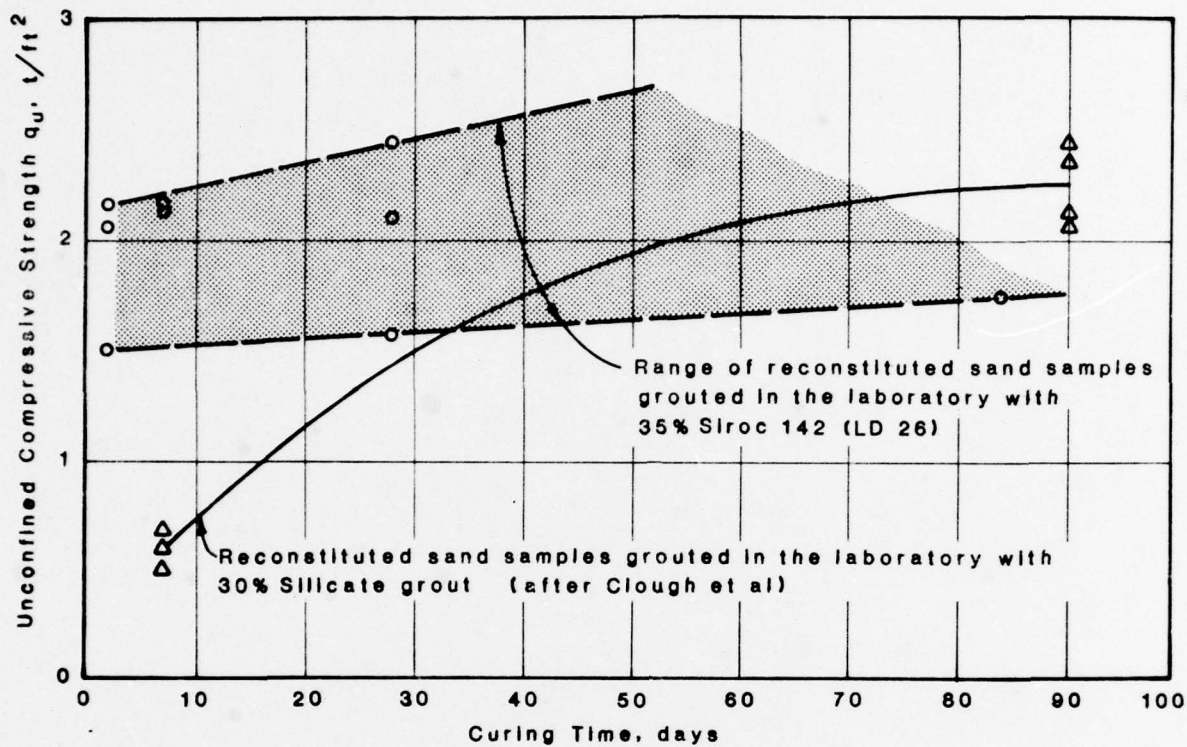
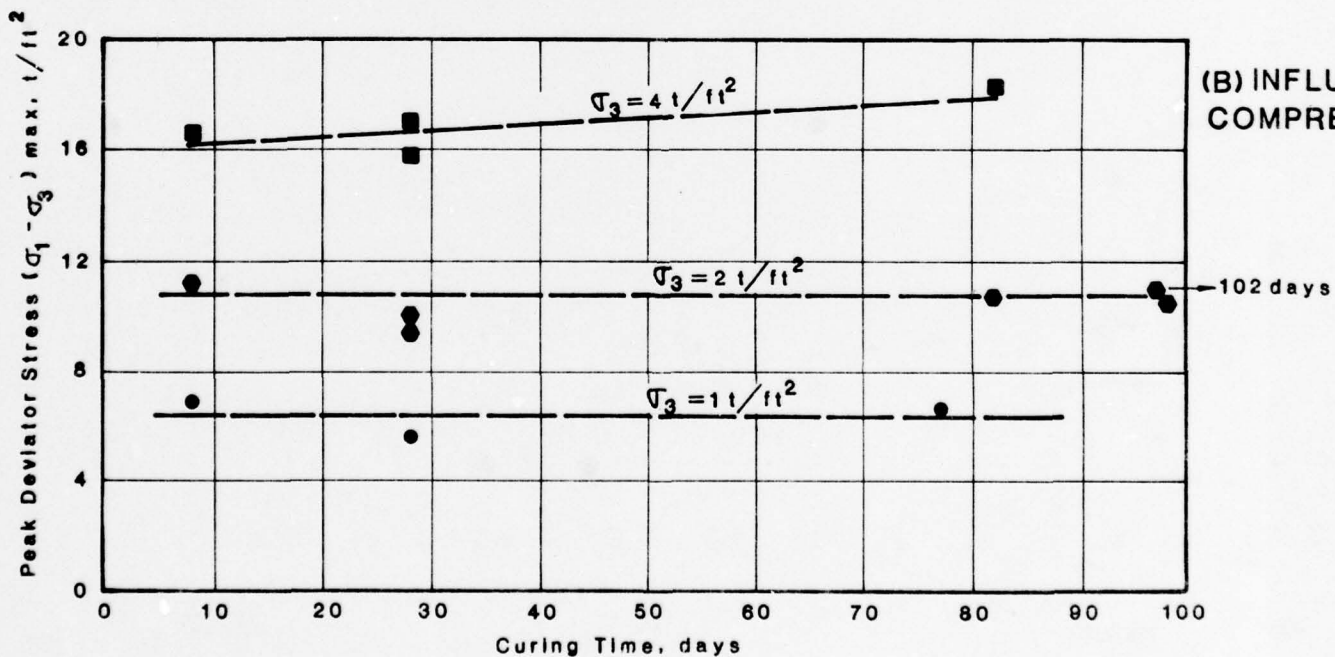
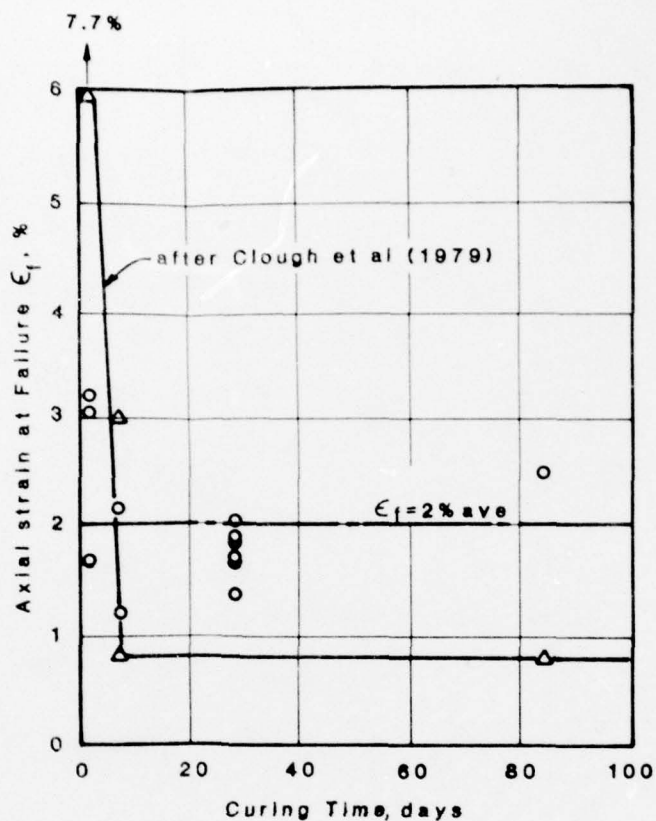
Fig. 9.45

(A) INFLUENCE ON UNCONFINED
COMPRESSIVE STRENGTH

(B) INFLUENCE ON TRIAXIAL
COMPRESSIVE STRENGTH

(C) INFLUENCE ON UNCONFINED
COMPRESSION AXIAL STRAIN
AT FAILURE

The influence of strain rate on unconfined compressive stress is illustrated in Fig. 9.45. The strength increased as the strain rate increased. This is in agreement with results reported by Clough et al (1979). Koenzen (1978) found that for 70% silicate grouts, the strength decreased by 45 percent when strain rate was decreased by three orders of magnitude. From those results, it is concluded that conventional laboratory loading rates (that is, about 0.5 percent per minute) may yield strength results up to 50 percent greater than slower loading rates that are more likely to occur in actual field loading.

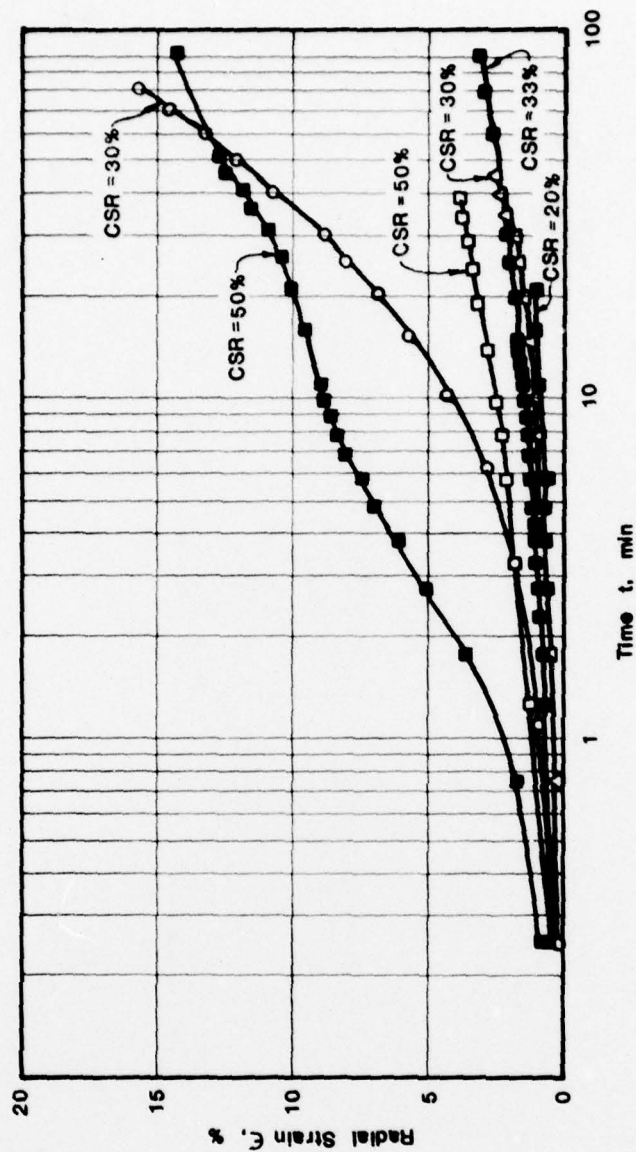
Fig. 9.52

- 25% Silicate/Aluminate, (Pile driving effects tests)
 - △ 45% Siroc 142, Subarea 5
 - 46% Silicate/R600, Subarea 13
 - 55% Siroc 142, Subarea 11
- $CSR = \sigma_r / \sigma_{r \max}$

Plate Load Tests. Results of long-term plate load tests are presented in Section 9.3.4. Creep rates $d\epsilon/dt$ deduced from these tests are plotted vs silicate content in Fig. 9.52. Creep rate increased with increasing silicate content. In Subareas 5, 10, and 11 (55% Siroc 132/142), the maximum applied stress never reached 50 percent of the ultimate plate bearing capacity, and the test data are not

shown in Fig. 9.52. Creep rates for these subareas were less than 0.007 percent per minute. However, in Subareas 12 and 13 (46% silicate/R600), which exhibited short-term strength similar to that of 55% Siroc 132/142, the observed creep rate was at least two orders of magnitude faster. Low-strength 25% silicate/aluminate also had a noticeable creep deformation tendency.

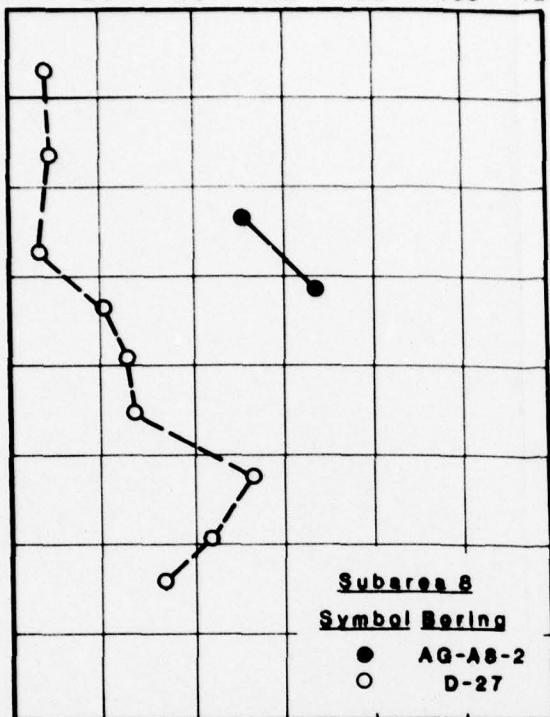
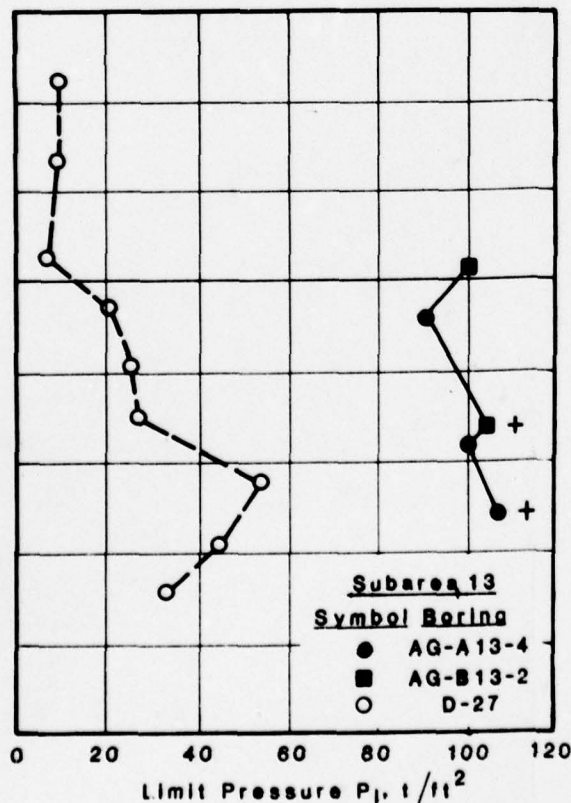
- Limit pressure after grouting
- Limit pressure before grouting (Boring D-27)
- + Failure not approached during test, $P_l > 100 \text{ t/ft}^2$

CHEMICAL GROUTING TEST PROGRAM
COMPARISON BETWEEN
PRESSUREMETER LIMIT
PRESSURES MEASURED
BEFORE AND AFTER GROUTING

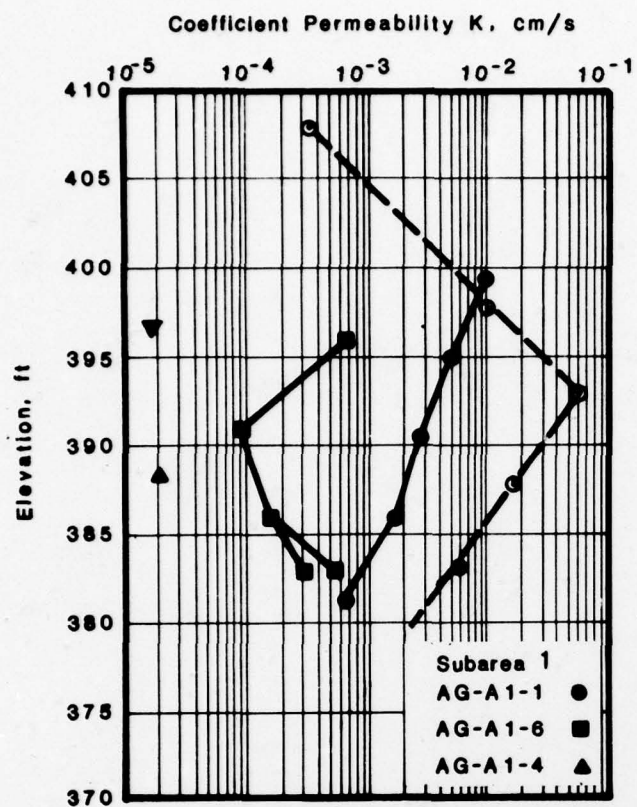
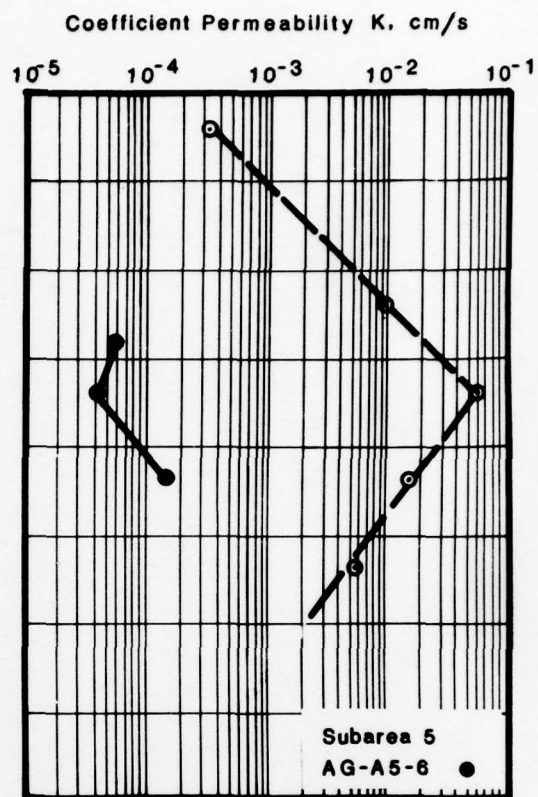
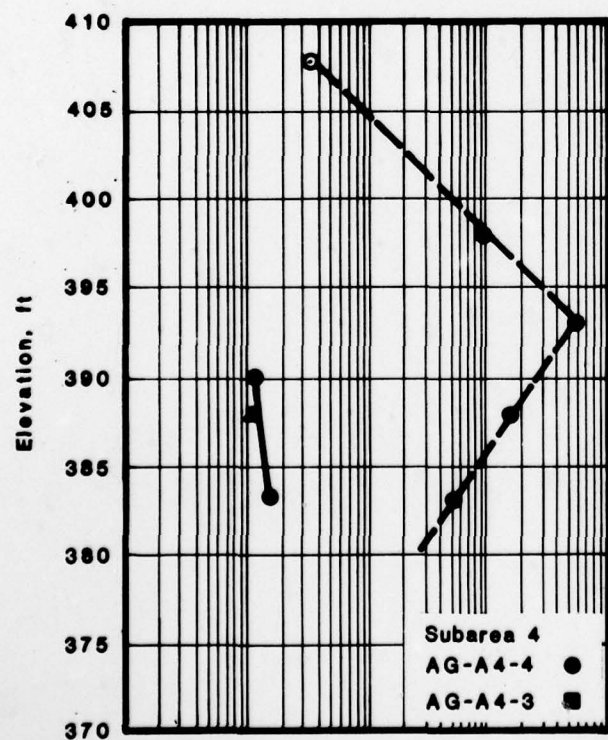
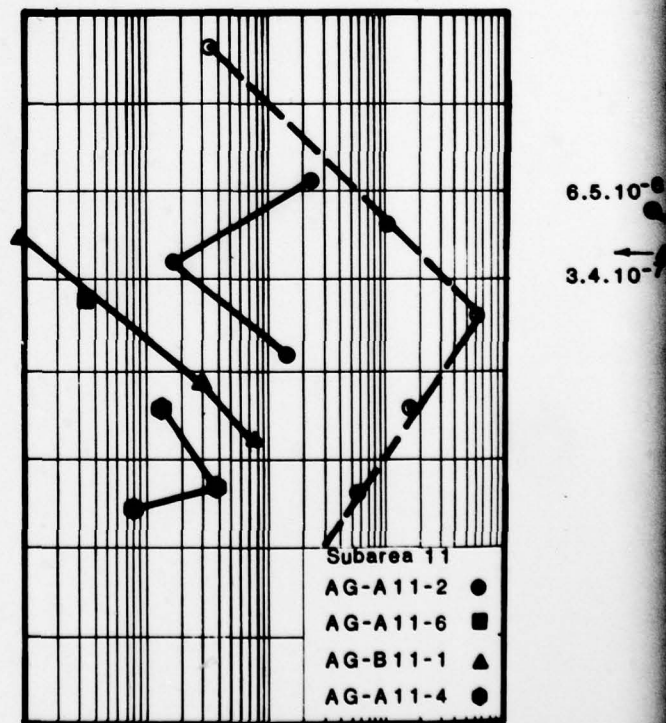
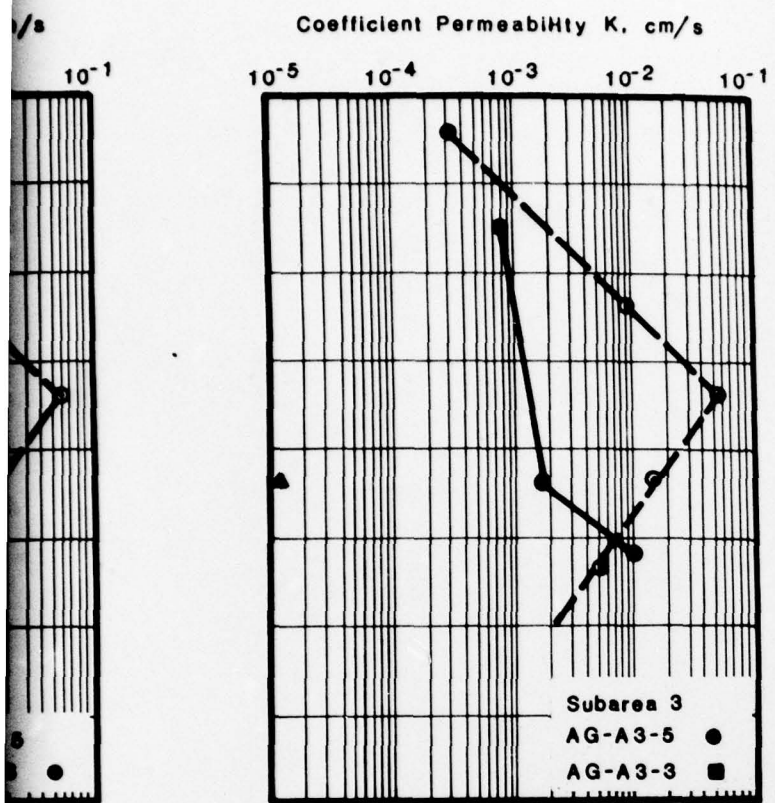
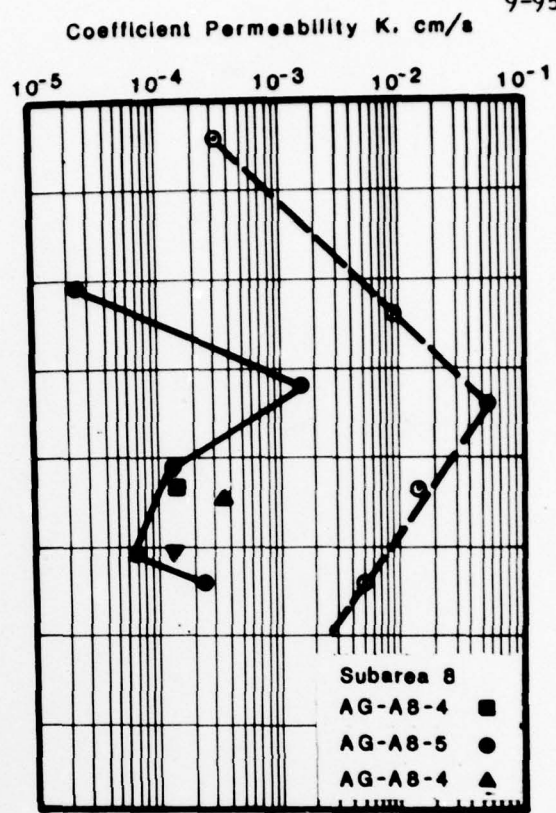
Fig. 9.47

- In situ test before grouting
- In situ test after grouting
- Lab test after grouting
- ▲ Undisturbed block sample
- ▼ Excavation block and core sample
